Bi-annual Environmental Monitoring Report

Project Number: 42399-02
ADB Loan No. 2755-KGZ (SF)
Reporting Period: January to June 2016

Kyrgyz Republic
CAREC Transport Corridor -1
(Bishkek – Torugart road) Project 3
Section Km479 to 539
(Financed by the Asian Development Bank)

Borrow Pit Restoration Audit

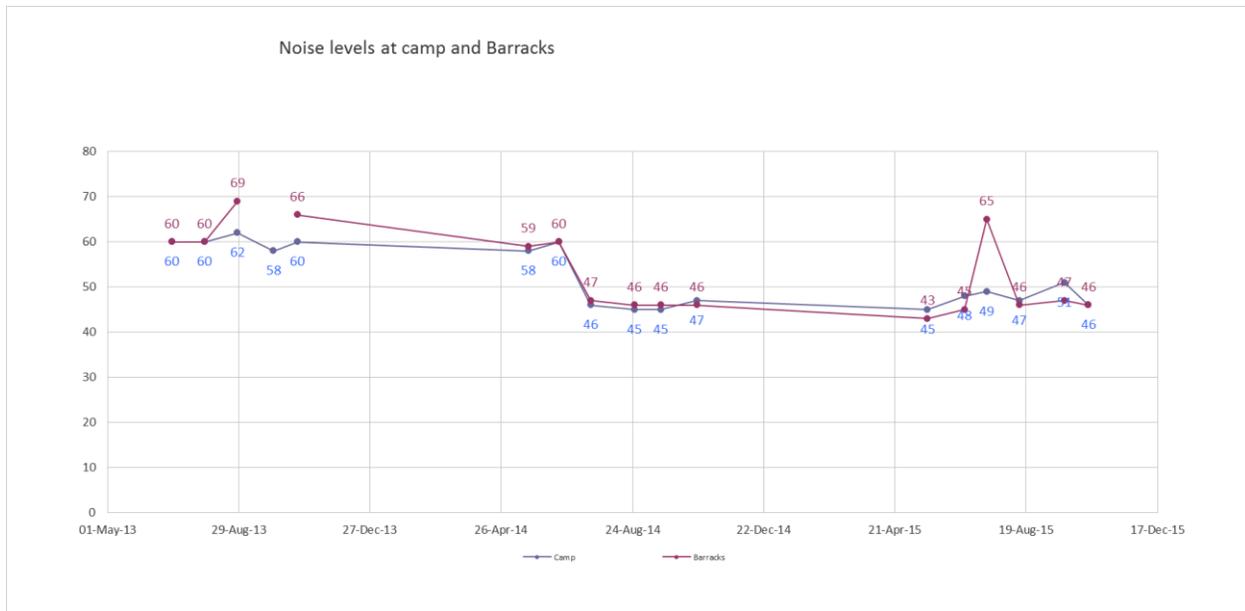
Figure 4: Noise Levels at the Camp and Barracks (May 2013 to June 2016)

21. Monthly monitoring of **noise** has been carried out in the 2013, 2014, 2015 and 2016 construction seasons. Since the laying of base course in the latter part of the 2014 construction season there has been a marked reduction in noise generated by road traffic (65dB to 45dB) at the camp monitoring station (Km501) and the barracks monitoring station (Km520). This is partly attributable to vehicles running on a smoother running surface. It is noted that in July 2015 the noise levels recorded at the barracks were elevated due to increased road construction activity in this area. The August 2015 data shows that pre-construction noise levels have returned and this trend continued until the end of the 2015 construction season and into 2016. The figure below illustrates this improvement. Note that there was no data collected in May and June 2016 due to poor weather conditions (wind and rain) on the sampling days.

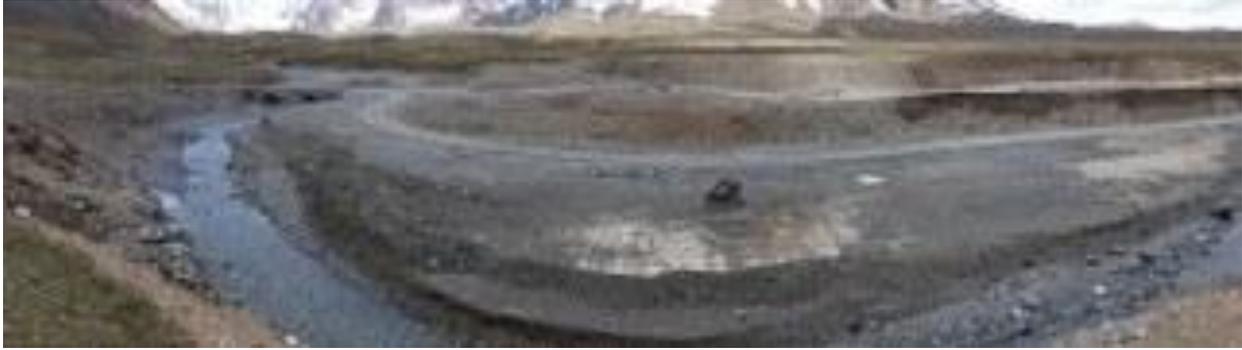
Figure 30: Muz Tor River Borrow Area – Note regrading on far bank, levelling foreground

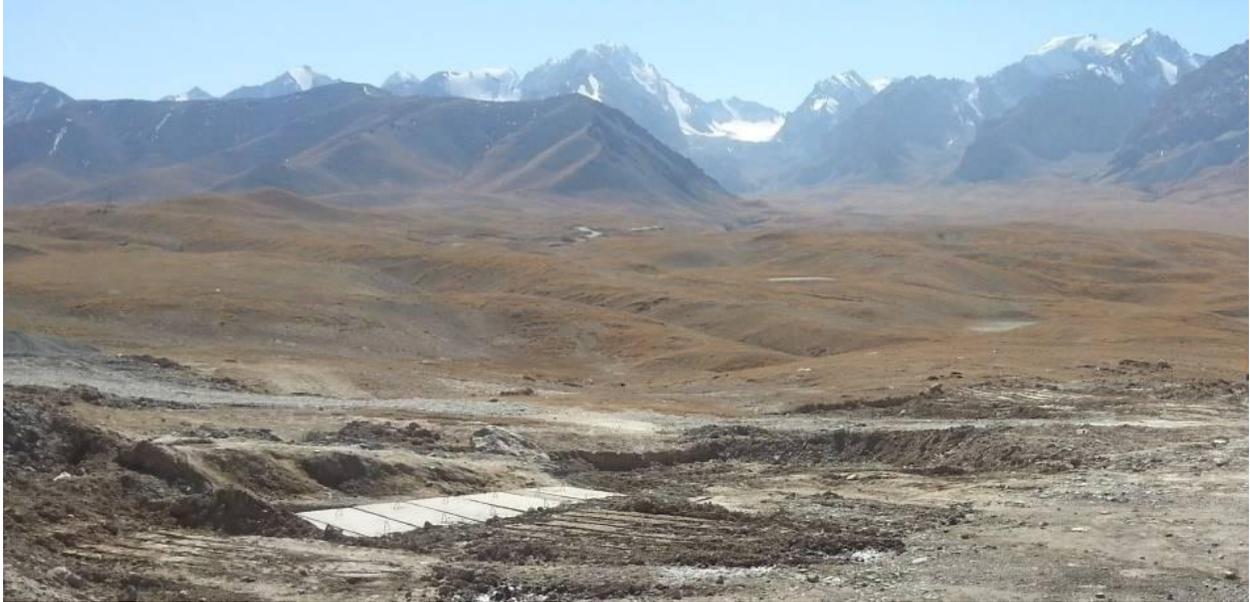
Figure 34: Septic Tank installed behind Camp – Emptied to facility at Naryn

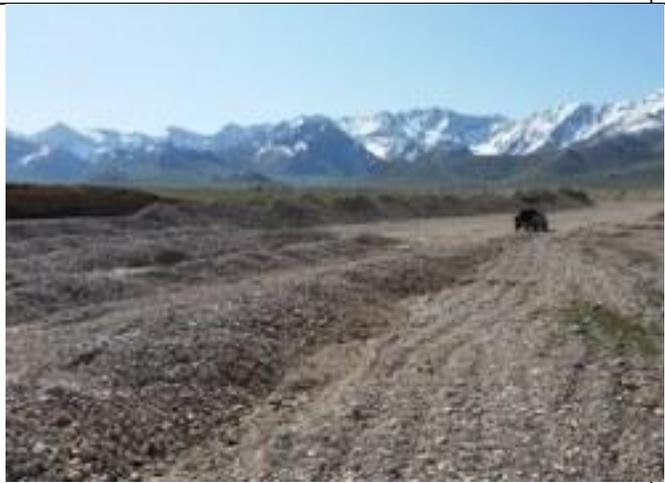
Pit #	Km	Checklist	Photos taken on 2 June 2016 (unless stated).	Other
B1	480+750 R	<p>Re-contoured to Restoration Plan</p> <p>All work complete</p> <p>Note. Additional levelling of the surplus material has been carried out since photo was taken</p>

<p>Source is a River Bed</p> <p>Further audit needed <input checked="" type="checkbox"/></p>

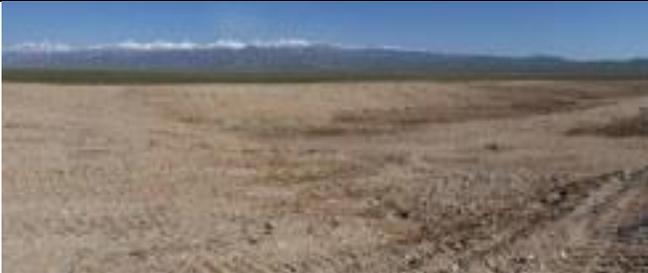
<p>B 2</p>	<p>484+4 00 R</p>	<p>Re-contoured to Restoration Plan</p> <p>All work complete</p> <p>Note. TERA has requested some additional re-contouring of the surplus material on the southern edge of the pit.</p>

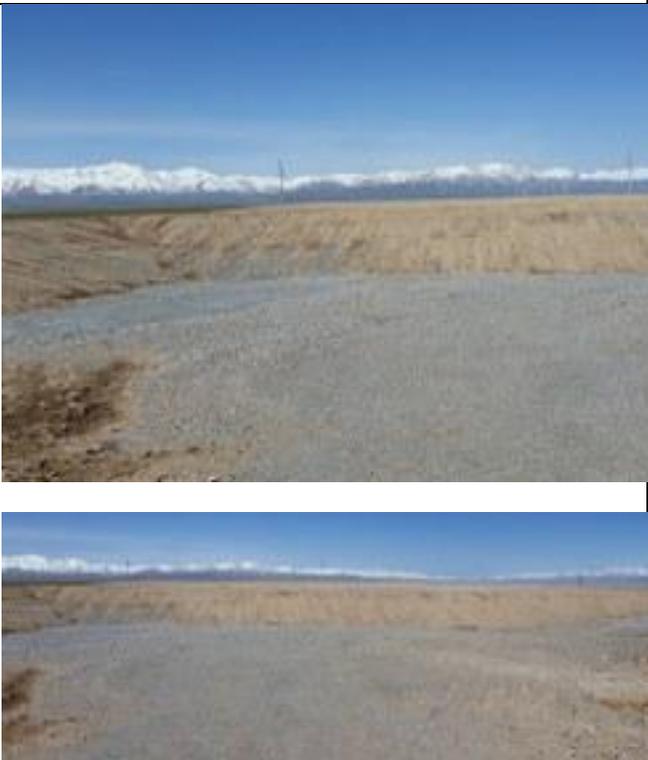
<p>Further audit needed <input checked="" type="checkbox"/></p>
<p>B 3</p>	<p>489+7 50 R</p>	<p>All work complete</p> <p>Re-contoured to Restoration Plan</p> <p>Note. This pit is identified in the restoration plan for the disposal of surplus inert material (e.g. out of specification products, unused sands and gravel, etc.)</p>

<p>Further audit needed on completion of any surplus material being disposed to this pit <input checked="" type="checkbox"/></p>

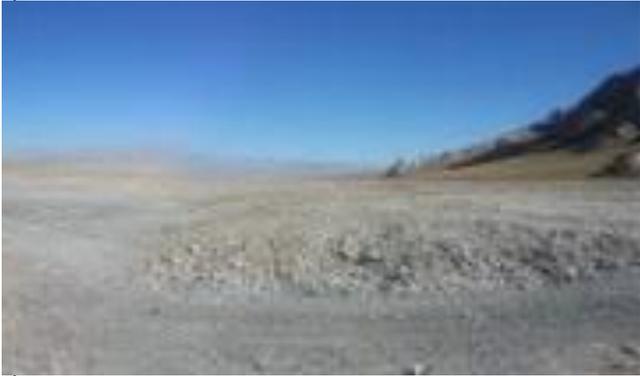
<p>B 4</p>		<p>491+1 00 R</p>	<p>Re-contoured to Restoration Plan</p> <p>All work complete</p>

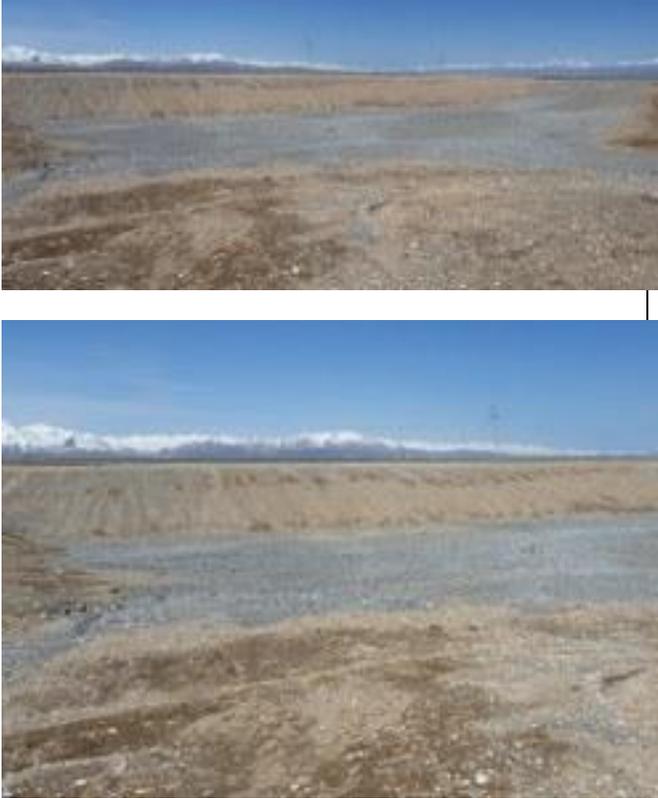
<p>River Bed</p> <p>Further audit needed <input checked="" type="checkbox"/></p>
<p>B 5</p>		<p>493+0 00 R</p>	<p>Re-contoured to Restoration Plan</p> <p>All work complete</p>

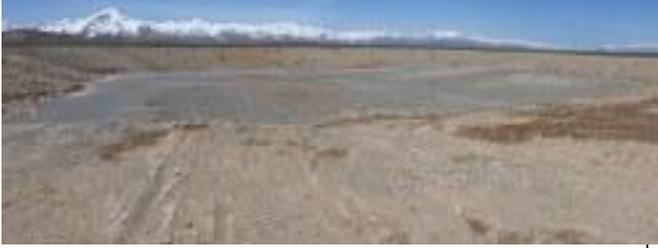
<p>B 6</p>	<p>495+5 00 R</p>	<p>Re-contoured to Restoration Plan</p> <p>All work complete</p>

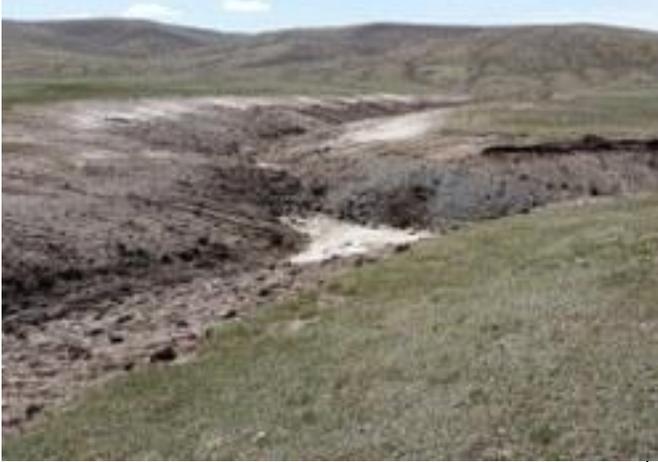
<p>Not used</p>
	<p>499+3 00 L</p>	<p>Re-contoured to Restoration Plan</p> <p>All work complete</p> <p>Note. New pit added for the 2015 construction season</p>
