Environmental Management Plan for PBM Stages

KGZ: CAREC Corridors 1 and 3 Connector Road Project

- **LOT 1: (Section 1: Balykchy (km 0) - Post 43 (km 43))**
- **LOT 2: (Section 2A: Kochkor (km 62+400) to – Epkin (km 89+500))**

October 2019

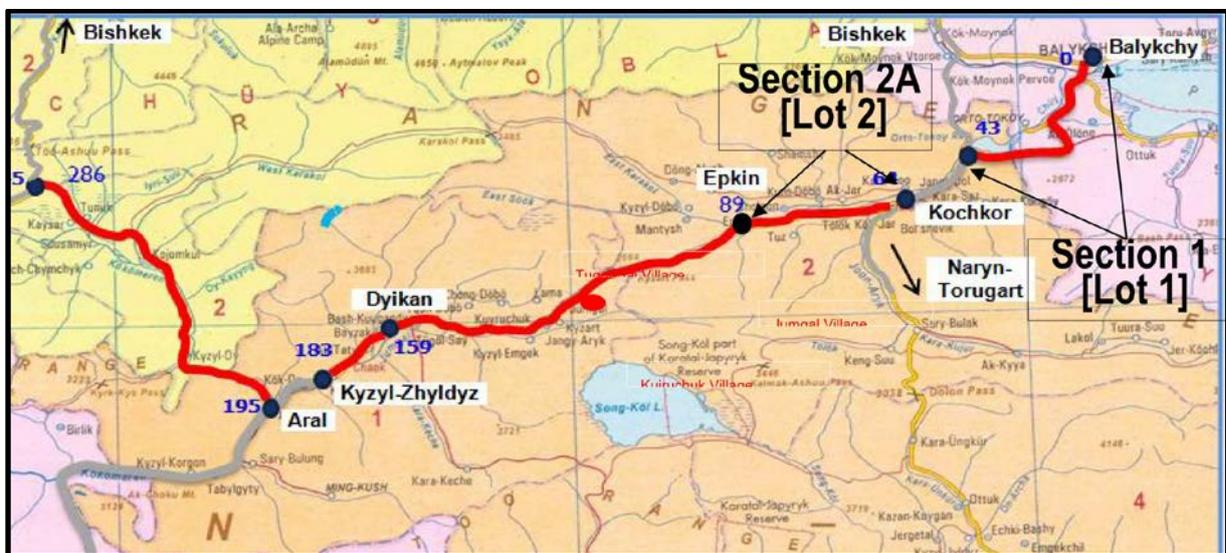
Figure 1: Section Location Map

Project routes are summarized in **Table 1: Project Sections**. Works Contract locations are indicated in **Figure 1: Location of Sections**.

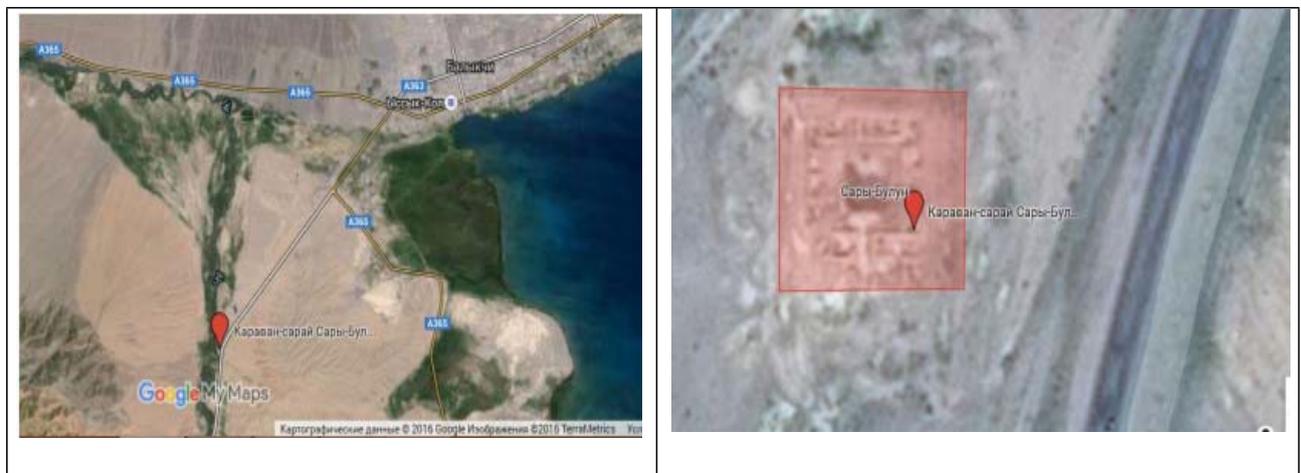
Figure 2: Archaeological Site Sary-Bulun Northern 1

- 1) Sary-Bulun Northern 1 (Figure 2) and 2- around 8 km from Balykchy in the direction of Kochkor, (RHS) 35 m to the north-west from the road. Roughly in a square, with sides of 40 metres. The maximum height of the surviving walls reach about 1.5 metres. This is the ruin of roadside inn discovered in 1971-1973 by Vinnik D.F.
- 2) Graves and a cemetery of ethnographic time (18th-19th centuries), a medieval settlement bronze-age village in the Tash-Saray locality was recorded in Section 1 at 10,800 metres from the beginning of the road. The sites are located on the east side of the existing road. The earlier graves have since been overgrown by more modern cemeteries. The graves are located about 40 metres from the existing road.

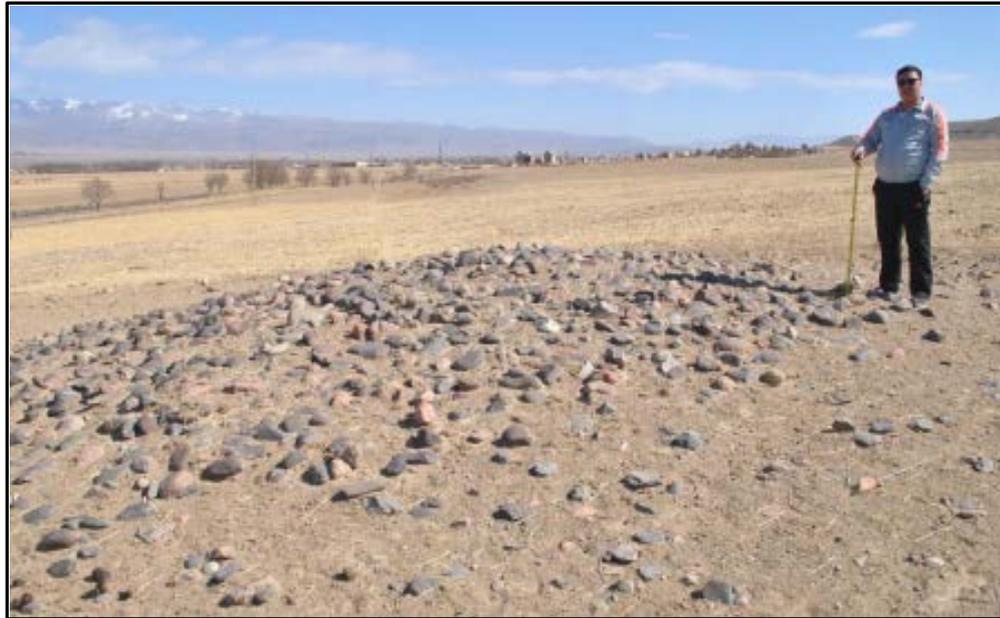
Figure 3: Location of Archaeological Sites near Cholpon Village

- 3) Within the section, the known significant archaeological resources consist of
 - (i) Eight (8) objects noted to be stone-earth mounds of the early nomadic times made up of mainly of small size gravel aggregates with a height from 0.2 to 0.7 metres and a diameter of 4 to 11 metres. These artifacts are located about 80-100 metres south side of the road south-west of the village of Cholpon (or LHS from the road) in Kochkor district (coordinates 42.18314 E75.45456 of N) between arable agricultural lands (see Photos below). Due to its distance from the road, the site should not be directly affected by construction activities. However, the Contractors should be informed of its presence and be instructed to avoid any disturbance to this area as shown in Figures 3 and 4.
